REPORT No. T 6/59

OPERATION ANTLER

The Effects of Blast on Dummies and Scout Cars

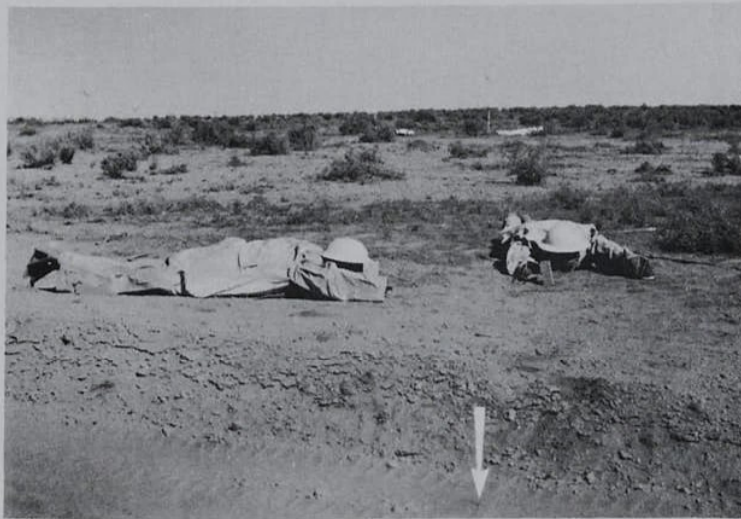
FIGURE 1

A standing dummy offers little frictional resistance to motion, and moreover does not require its centre of gravity to be lifted before becoming airborne. It would therefore be expected to suffer relatively greater displacements than prone and crouching dummies of similar presented area. This does appear to be borne out in Figure 1 where standing dummies show consistently higher displacements.

increased. The resulting translational impulse is thus considerably greater. Displacements of the prone dummies exposed to Round 3, although substantial, were not greater than would have been expected from these considerations, as can be seen in Figure 1. The two unexpectedly low values were obtained from dummies at Target 501, sited 10 ft behind a very small ridge 9 in. high, and illustrates the protection from blast which can be gained from quite small features.

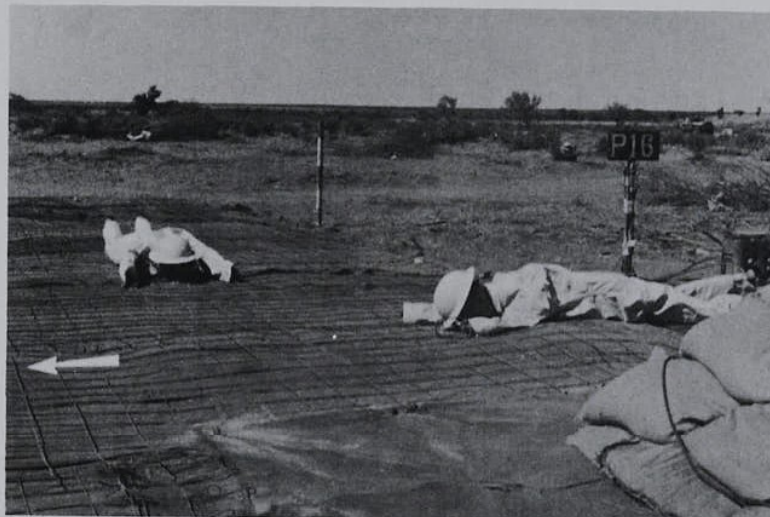
FIGURE 6. ROUND 2. PRONE DUMMIES AT 2000 ft BEFORE FIRING.
NOTE SEALED SURFACE OF WIRE MESH ON TARPAULINS
SECURED BY STAKES

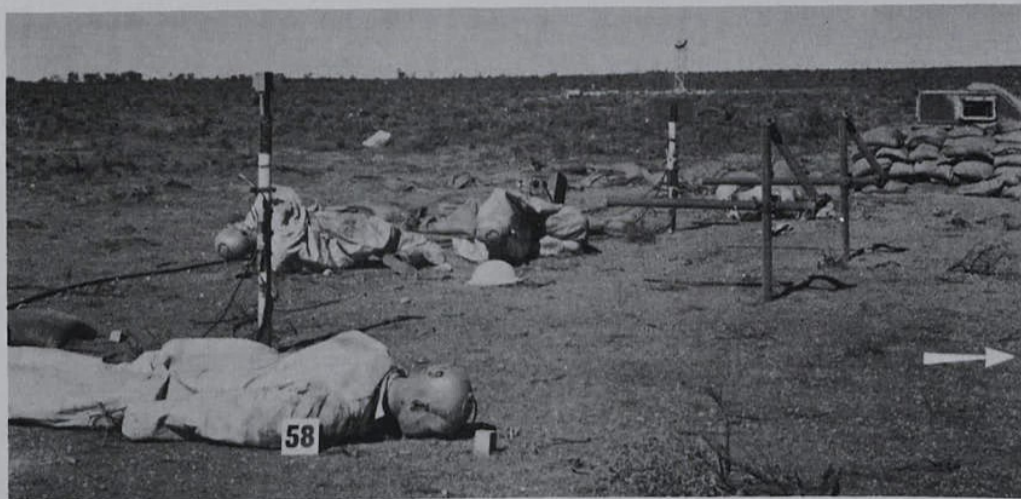
FIGURE 9. ROUND 2. DUMMIES AT 2200 ft. NOTE WHITE NAILS IN FRONT OF PRONE FACING DUMMY USED AS A REFERENCE MARK

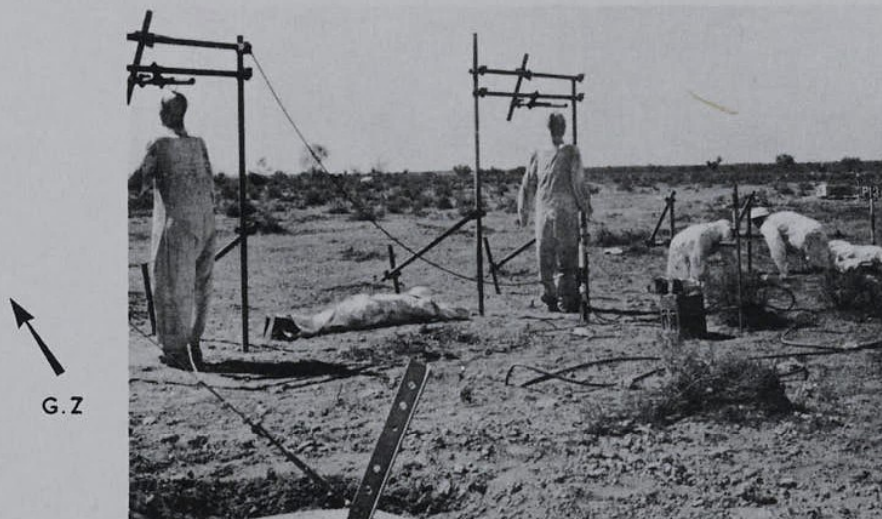
30 dummies were exposed in the open at various ranges in different postures - standing, crouching, or prone - each posture being repeated facing and sideways-on to Ground Zero. The standing and crouching dummies were supported on a frame-work of tubular scaffolding (see Figures 8 and 10). One dummy was standing in a trench (see Figure 23).

FIGURE 10. ROUND 2. DUMMIES AT 2390 ft BEFORE FIRING.
NOTE SCAFFOLDING USED TO SUPPORT DUMMIES

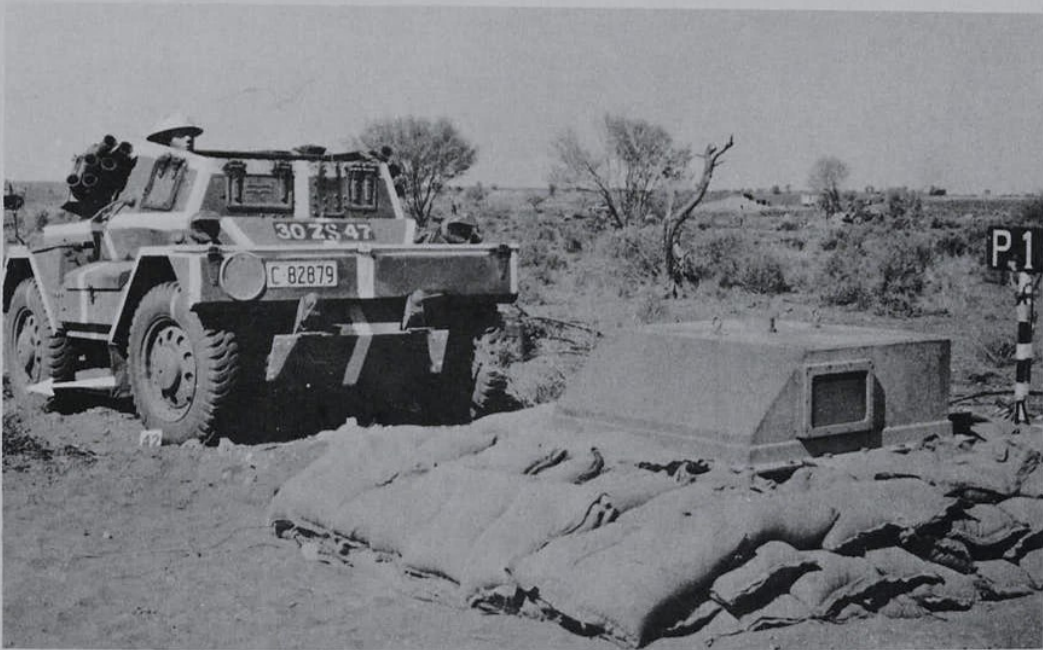
Because the yield of Round 2 was designed to be lower than had been assumed in the initial planning, the Daimler Scout Cars were not subjected to a large enough blast pressure for them to be greatly affected. Only the leading car at 1730 ft from Ground Zero had moved at all significantly. This car turned onto its side, spilling its dummy driver onto the ground, but did not undergo any actual translation. All the cars could be driven away after exposure. In the other cars at 2200, 2530 and 2650 ft movement was only a few inches and the dummy drivers were not affected. Details are shown in Appendix C and Figures 20, 21 and 22.

FIGURE 20. ROUND 2. SCOUT CAR AT 1730 ft BEFORE FIRING.
THIS ALSO GIVES GOOD VIEW OF TERRAIN IN THE
TARGET AREA

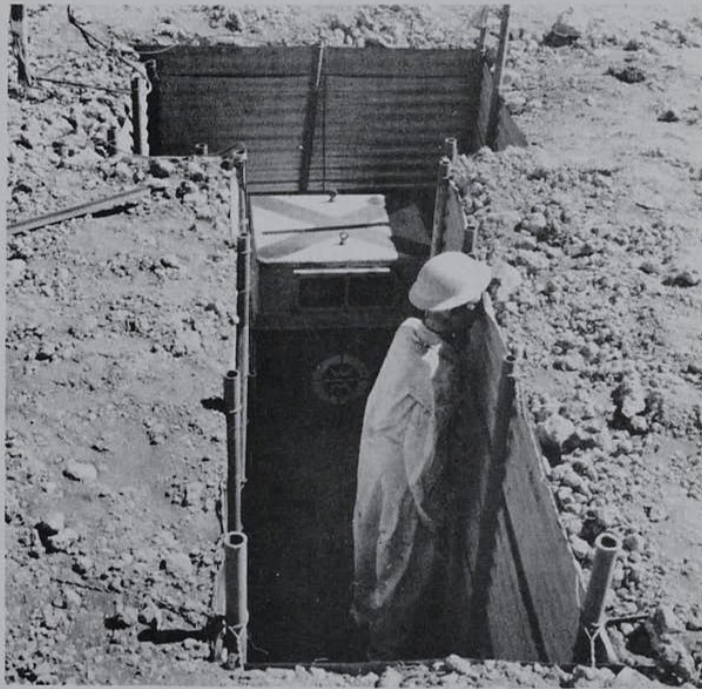
On Round 2, one dummy was standing in a trench which was at right angles to the radius from Ground Zero at Site P17 (2390 ft). The dummy was facing Ground Zero with the rim of its steel helmet about level with the lip of the trench (see Figure 23). This dummy was exposed primarily to test a camera installation, but after firing it was observed that it had not moved and had apparently suffered no damage (see Figure 24).

FIGURE 23. DUMMY IN TRENCH AT 2390 ft BEFORE FIRING
